Inspecting Your Adventure Playground

Guidance for playworkers who are carrying out routine visual and operational inspections on their playground(s)

> Rob Wheway January 2019

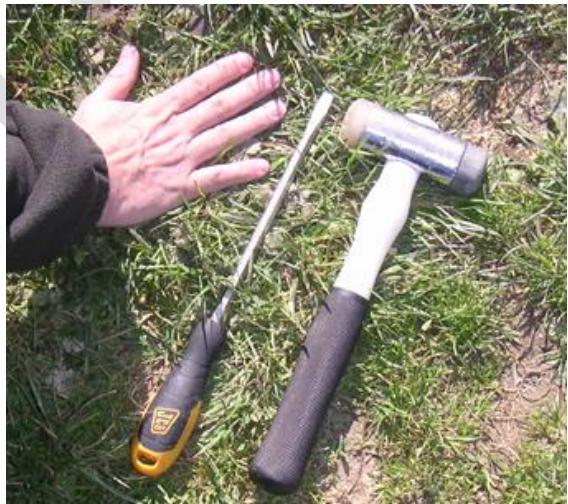
The second a flat head screwdriver which is available from a variety of manufacturers. It is the most common size for a good stout screwdriver. These normally have a blade length of 200mm.

Tools used at inspections

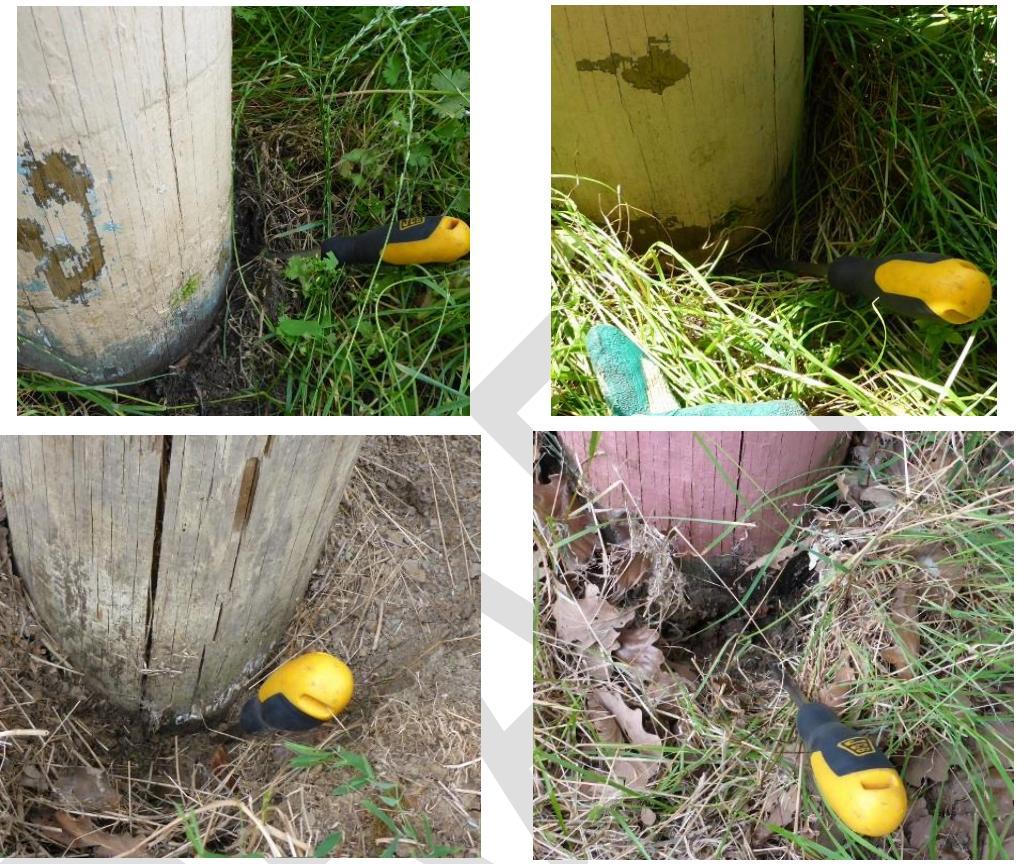
Supports tend to rot/rust just below ground level. The screwdriver should be pushed in 2-4 inches below the surface. Because it's a flat-head it should only cause damage if the support is already deteriorating.

Inspecting for rot with a screwdriver

I would avoid sharp screwdrivers or probes as these will penetrate the wood even when it is sound. Over time you will give the wood perforations which will weaken it. They may also allow bacterial or fungal matter to get into the untreated wood at the centre of the support.

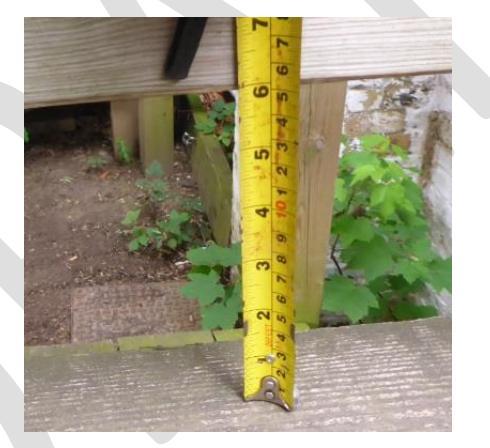
Item 1	Main Structure		
	Section 1: 2 Tower	s (starting at building	g end)

Gaps between steps give head entrapment potential – *Infill to reduce to max. 89mm* – *Low/Medium Risk (does not apply when distance to deck is less than 600mm).*

Gaps between barrier uprights exceeds 89mm. As they are at 100mm the risk is acceptable.

Severe rot at 4 supports - Replace or fit slaves - Medium Risk

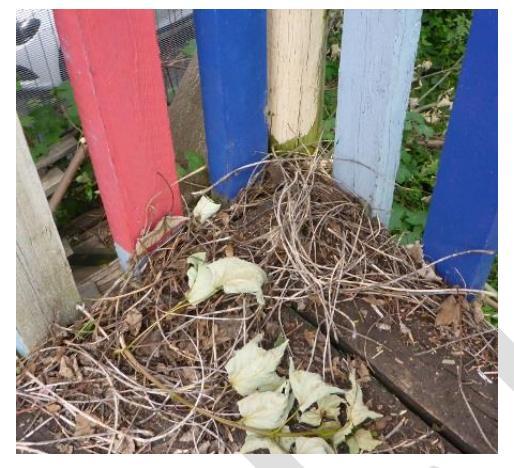
Item 1 Main Structure Section 2: Up Long Ramp to Middle Deck (anti-clockwise)

Loose plank at yellow steps – *Make secure* – *Low/Medium Risk Remove dead leaves/moss from corner of decks as they encourage rot*

4 missing uprights and missing section between climb wall and ramp – *Replace* planks – Low/Medium Risk

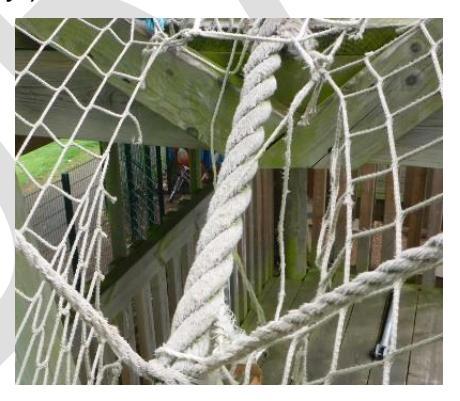
Item 1	Main Structure
	Section 3: Long Rope Bridge

Fall arrest net holed at near end – *Repair* – *Medium Risk* (Ropes have been fixed to indicate that the bridge it is out of use. It is, however, easy to get past these ropes and the bridge is an obvious inducement for children, therefore the net should be repaired with some urgency.)

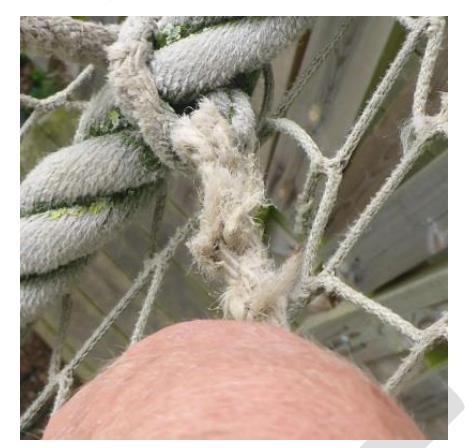
Vertical rope at far end is breaking/fraying - Replace - Low/Medium Risk

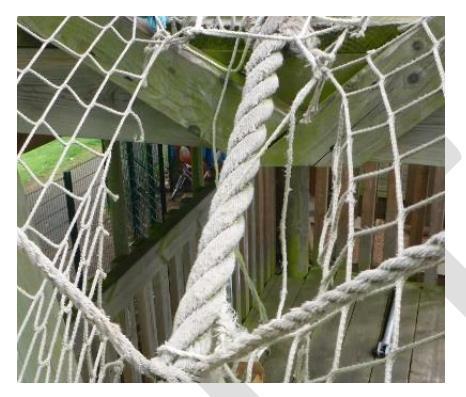
Item 1 Main Structure Section 3: Long Rope Bridge

Fall arrest net holed at near end – *Repair* – *Medium Risk* (Ropes have been fixed to indicate that the bridge it is out of use. It is, however, easy to get past these ropes and the bridge is an obvious inducement for children, therefore the net should be repaired with some urgency.)

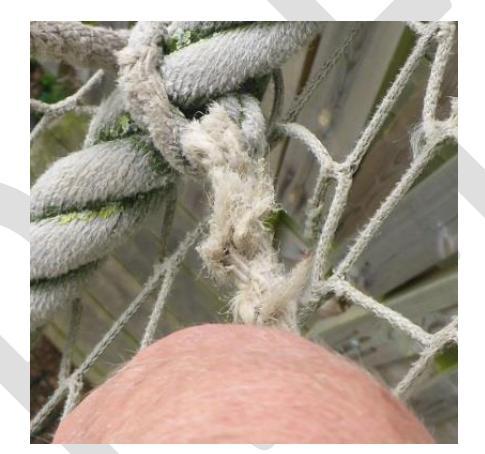
Vertical rope at far end is breaking/fraying - Replace - Low/Medium Risk

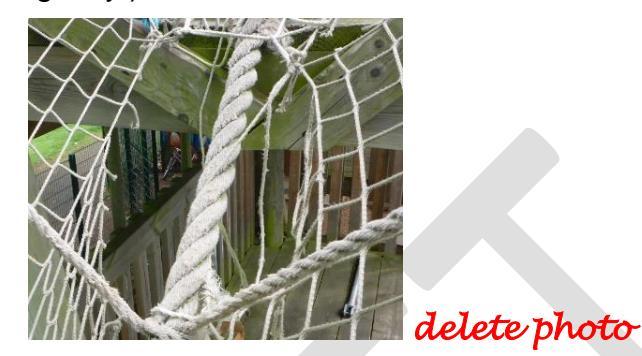
Item 1 Main Structure Section 3: Long Rope Bridge

Fall arrest net holed at near end – *Repair* – *Medium Risk* (Ropes have been fixed to indicate that the bridge it is out of use. It is, however, easy to get past these ropes and the bridge is an obvious inducement for children, therefore the net should be repaired with some urgency.)

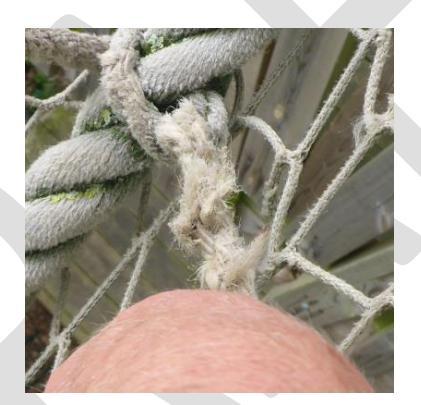
Vertical rope at far end is breaking/fraying – Replace – Low/Medium Risk still needs doing

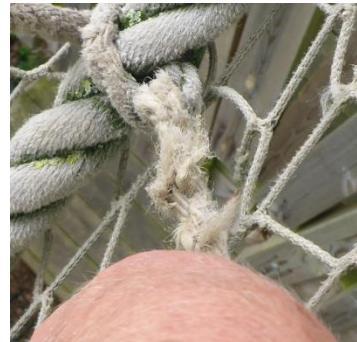
Item 1	Main Structure
	Section 3: Long Rope Bridge

Vertical rope at far end is breaking/fraying – *Replace – Low/Medium Risk still needs doing*
